**MOISTURE
INDUCED
PROBLEMS
IN NHA HOUSING**
Summary Report

**MARSHALL MACKLIN MONGHAN LIMITED
Consulting Engineers, Surveyors, Planners
Toronto**

October 1984

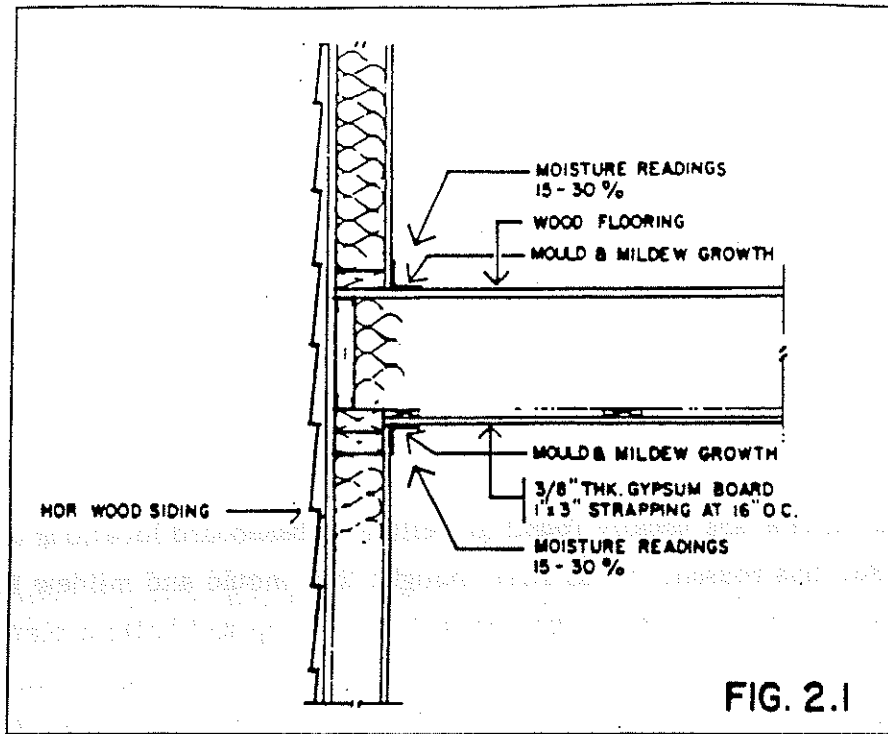
EXTERIOR WALL / FLOOR JUNCTION

Mould and mildew are usually found at ceiling or baseboard locations on outside walls⁶⁾. For this reason, it was first thought that mould and mildew formation was related to the thermal bridges caused by the top and bottom plates of the wall framing. However, further investigation found that, although wall surface temperatures will be somewhat lower in thermal bridge locations (i.e. lower thermal resistance of the wood members as compared to the insulated wall), the surface temperature will still be high enough that condensation should not take place, except under extreme conditions of high inside RH and low outside temperatures. With these factors in mind, a further analysis, aimed at determining the reasons for mould and mildew growth in these locations, was undertaken by the researchers.

6) See Figures 2.1, 2.2 and 2.3 for typical mould and mildew locations.

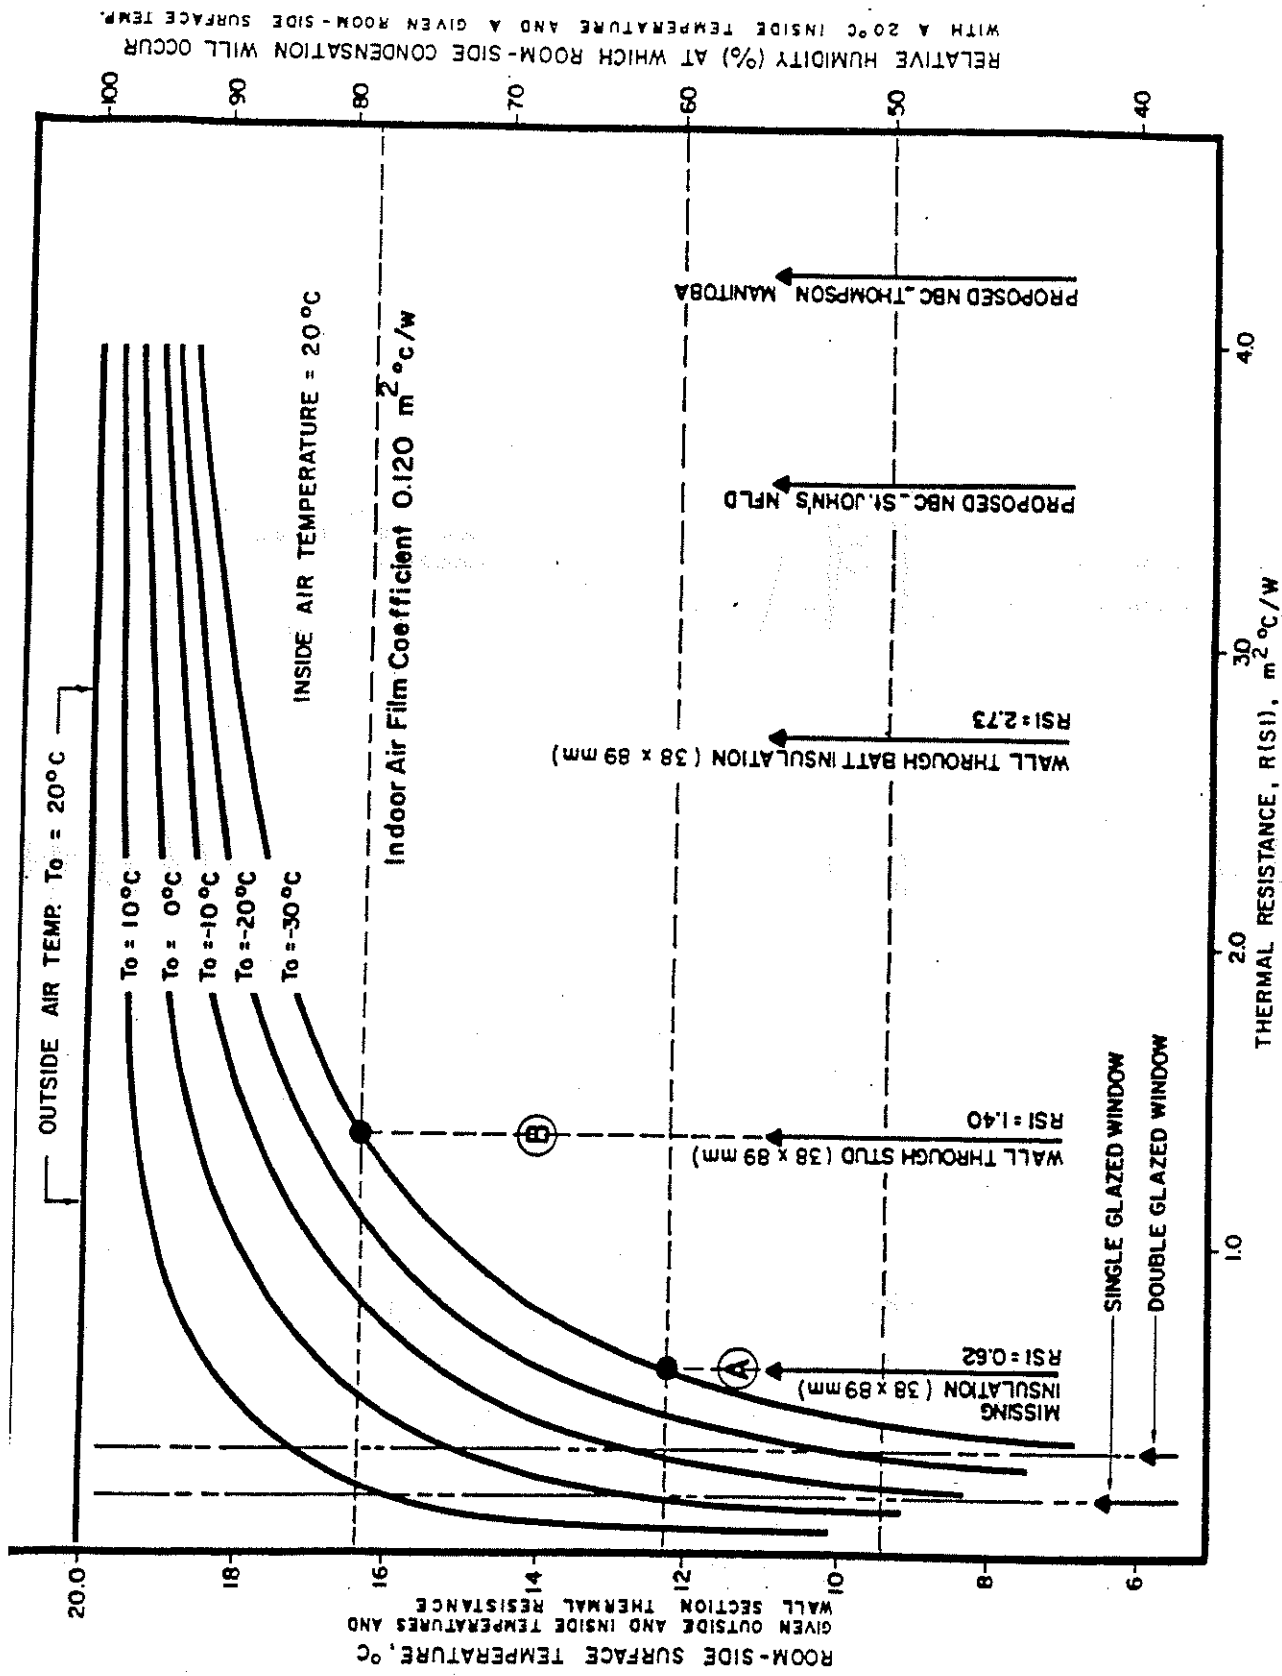
FIG. 2.4

The results of these analyses, showing the theoretical dewpoints of inside air, given a range of temperature, humidity and wall system conditions, are shown in Figure 2.4. The range of curves can be used to determine the inside wall temperature and, therefore, the inside relative humidity that can be tolerated at 20°C given a range of outside temperature conditions and typical wall sections.

As an example, theory, indicates that condensation on a wall surface with missing insulation, should not start before the outdoor temperature falls below -30°C or the indoor relative humidity exceeds 60 percent (at 20°C) -Example "A". Similarly, at this outside temperature, condensation should not take place at a stud location until the indoor relative humidity exceeds about 75 to 80 percent (at 20°C) - Example "B". Field conditions were, however, different and mould and mildew was observed in problem buildings under conditions where theory indicates that condensation should not occur at either a thermal bridge location or even at a wall section with missing insulation. This suggests that, at certain locations, air movement within the wall system has resulted in lower inside surface temperatures than would normally be expected.

As can be seen from Figure 2.4, if the RH values are permitted to rise window condensation is to be expected, even with double glazing. With single glazing, given an inside temperature of 20°C and a relative humidity of 50 percent, condensation can be expected when the outside temperature drops below 0°C. Even with double glazing, condensation can be expected when the outside temperature falls below -20°C.
